REC'D 6-19-87  
FB.RCRA RECORDS CENTER  
FACILITY Ciba Geigy Corp  
ID. NO. RID001194323  
FILE LOC. R-5  
OTHER \_\_\_\_\_VISUAL SITE INSPECTION REPORT  
RCRA FACILITY ASSESSMENT  
CIBA-GEIGY CORPORATION  
CRANSTON, RHODE ISLAND

U.S. ENVIRONMENTAL PROTECTION AGENCY  
Office of Waste Programs Enforcement  
Washington, D.C. 20460

Work Assignment No.	:	265
EPA Region	:	I
Facility ID No.	:	RID001194323
Date Prepared	:	June 11, 1987
Contract No.	:	68-01-7331
CDM Federal Programs	:	
Corporation Document No.	:	T265-R01-RT-AQXF-3
Prepared By	:	Versar
Work Assignment Project Manager	:	Dennis Giestra
Telephone Number	:	(703) 750-3000
Primary Contact	:	Frank Battaglia
Telephone Number	:	(617) 223-1961

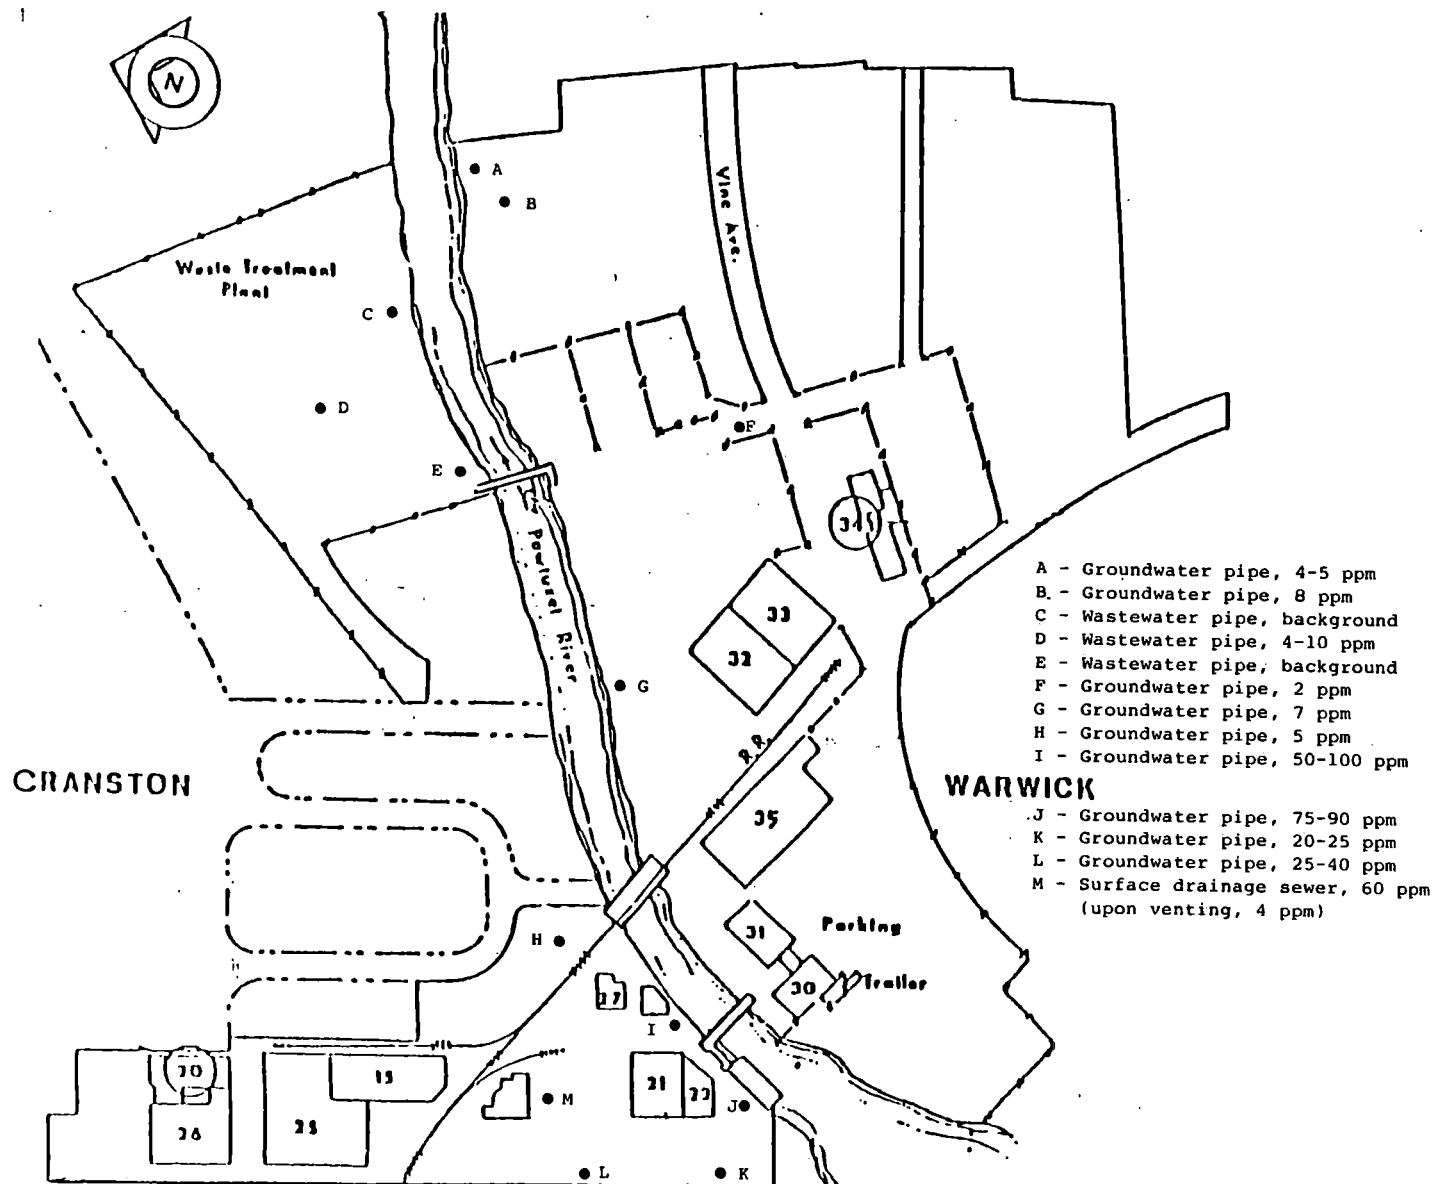
FIGURE 1  
TIP PHOTOIONIZATION READINGS TAKEN DURING VISUAL SITE INSPECTION OF  
CIBA-GEIGY CORPORATION, CRANSTON, RHODE ISLAND.  
(Ciba-Geigy, 1985b)

Ambient air monitoring for possible organic vapors was conducted by Versar during the VSI using a Photovac TIP (total ionizables present) photoionization unit. Instantaneous readings were taken at various locations onsite in order to detect the presence of photoionizable constituents in ambient air. No detectable readings above background were recorded during the VSI for all measurements taken at the breathing zone. Several significant readings, however, were recorded for subsurface locations throughout the facility which were accessed by an underground surface drainage sewer, 1 1/4-inch diameter piezometers (Photo 1), and former wastewater piping. These locations and the levels detected are shown in Figure 1. All readings from these locations were taken prior to any venting of the subsurface opening (except for the wastewater pipes which were not covered) and are only an indication of the possible presence of organic vapors above background levels.

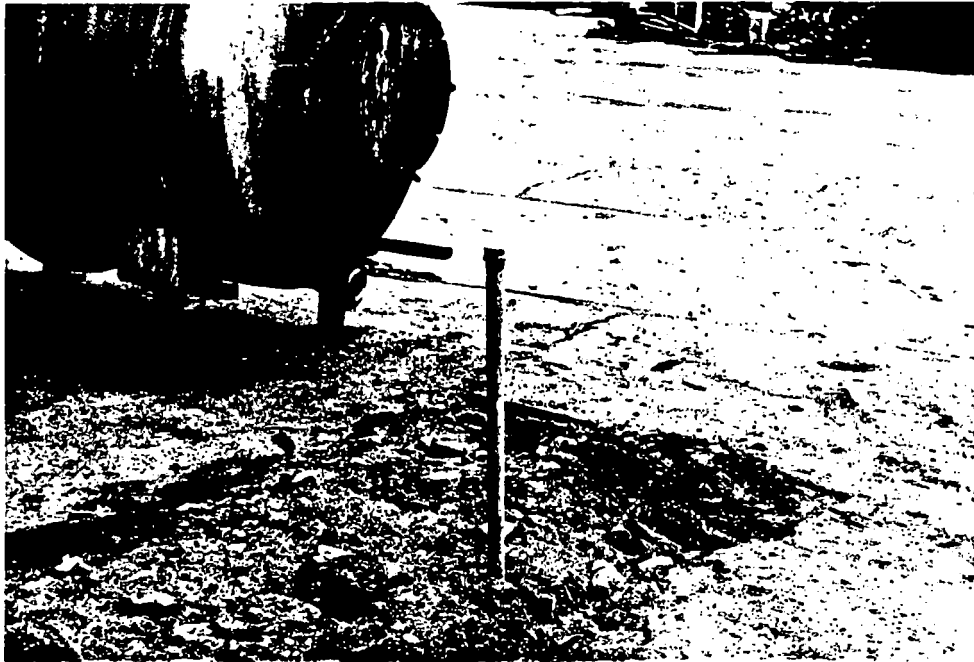
PHOTO 1

SUBJECT: PIPE RECENTLY INSTALLED TO MEASURE GROUND WATER LEVELS.  
SEVERAL SIMILAR PIPES EXIST THROUGHOUT THE FACILITY.  
LOCATION: CIBA-GEIGY, WARWICK, RHODE ISLAND  
DATE: MAY 8, 1987

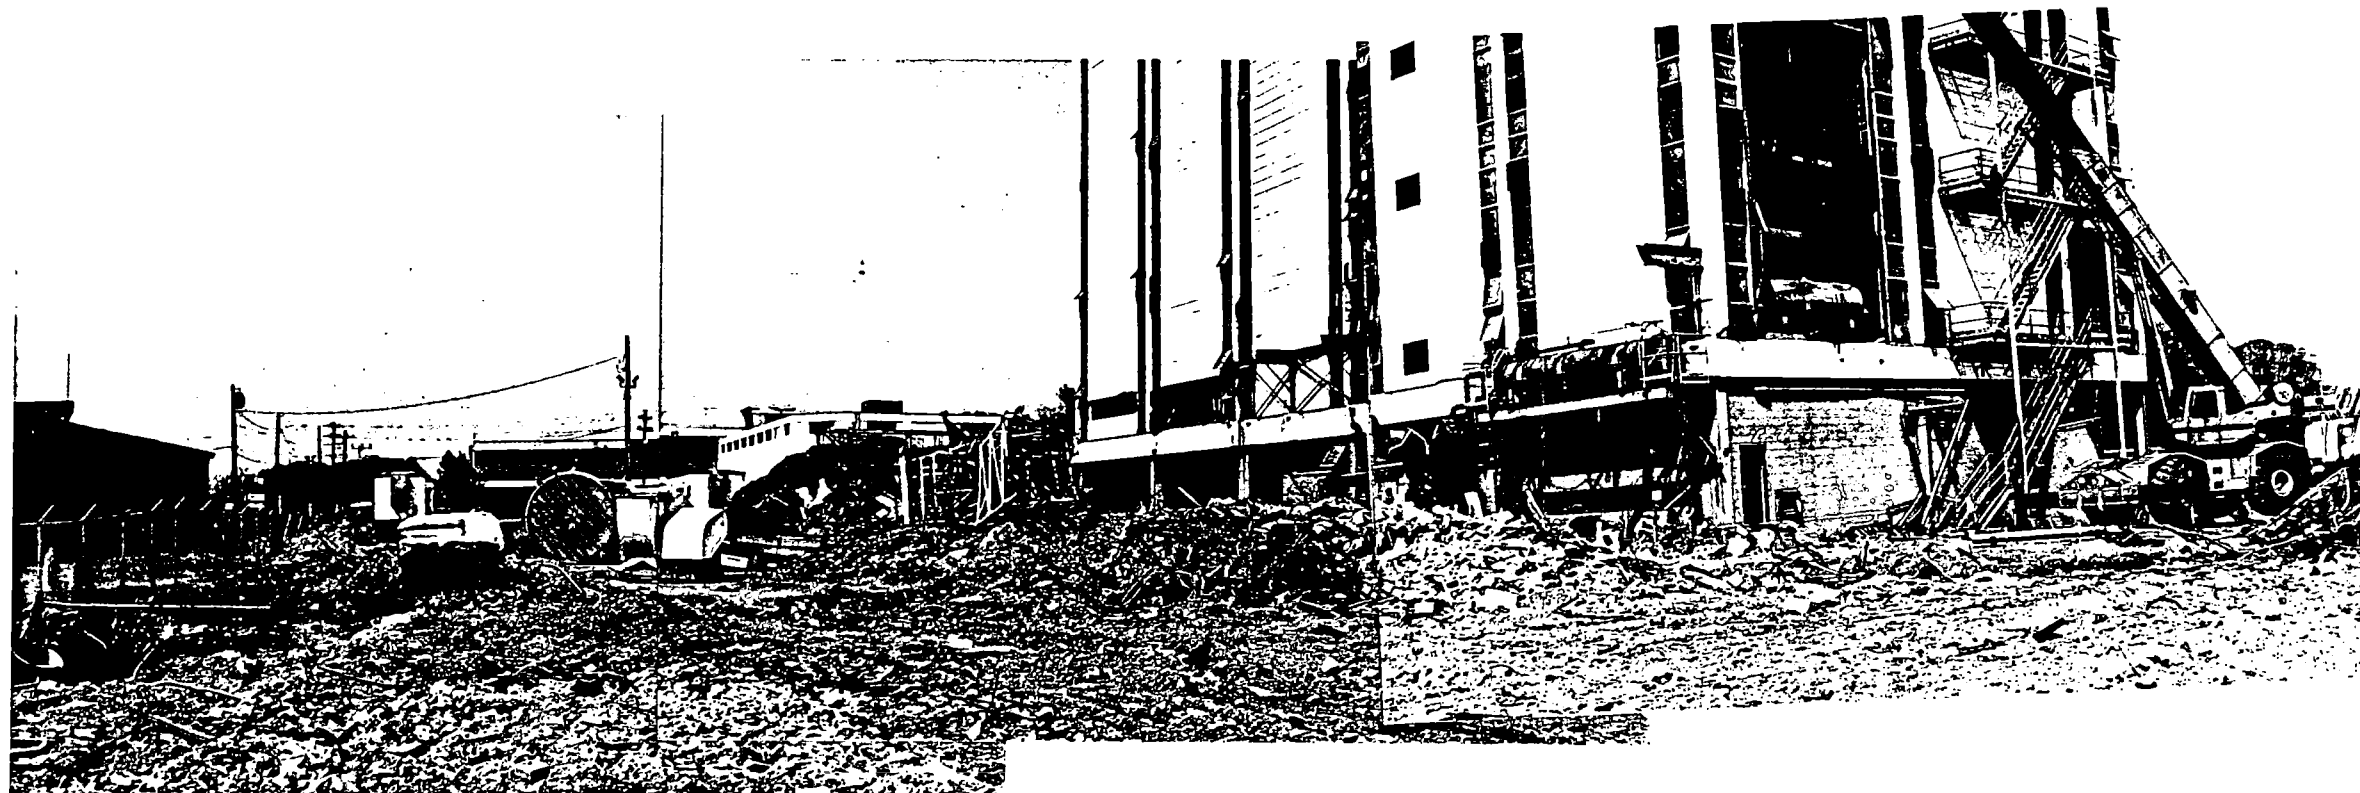
PHOTO 2

Photographs of the Ciba-Geigy facility and all SWMU locations were also taken during the visual site inspection (see Attachment A) in order to document site conditions. Visual evidence of releases from the facility was not readily apparent at locations around the plant. At the time of the VSI, it was evident that demolition of the facility was well under way (Photos 2 and 3) and that process operations had ceased.

SUBJECT: DEMOLITION ACTIVITIES AROUND BUILDING 21/22 IN SOUTHWEST CORNER OF THE SITE  
LOOKING NORTHEAST.

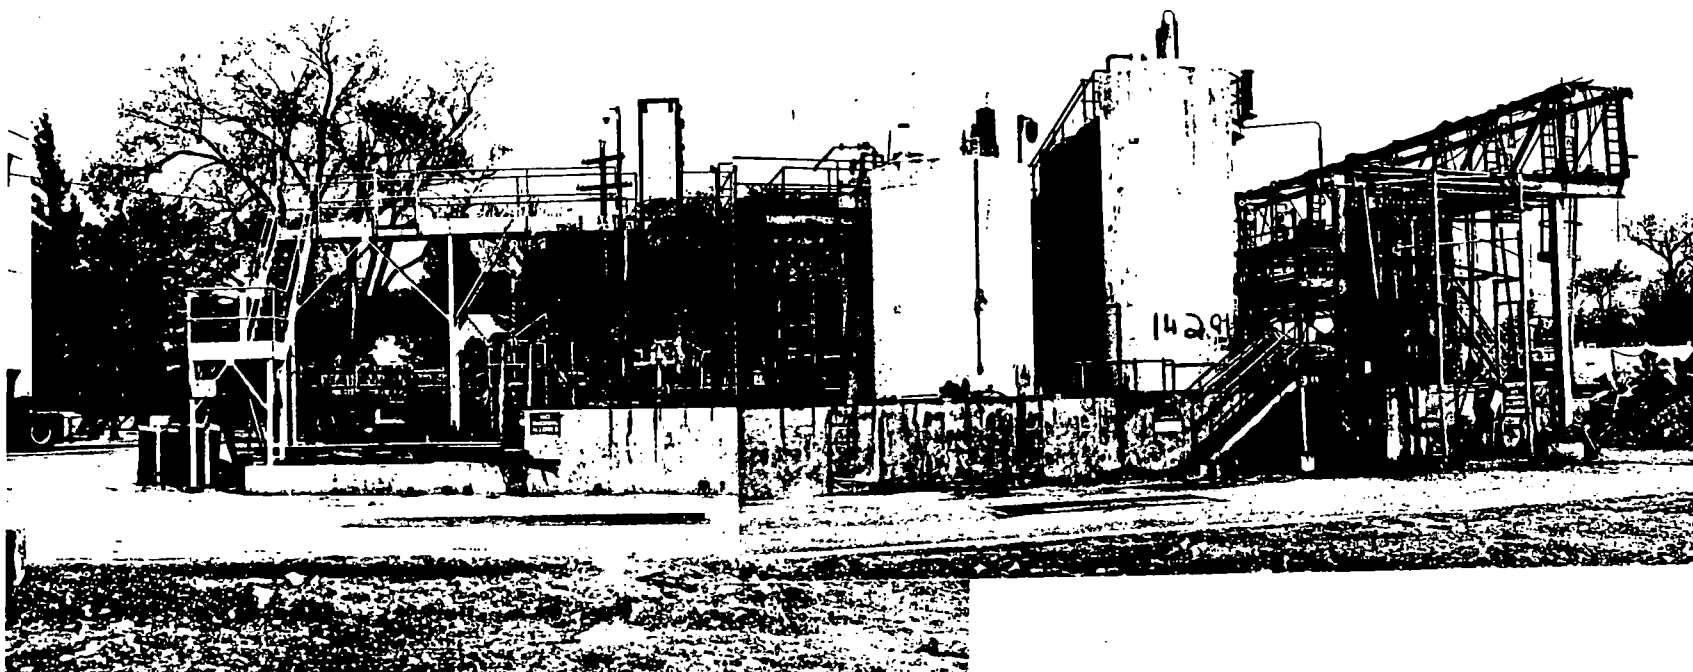
PHOTO 3

SUBJECT: MAIN TANK FARM WHICH CONTAINED SWMU2 AND SWUM 3 LOOKING EAST.  
LOCATION: CIBA-GEIGY, CRANSTON, RHODE ISLAND  
DATE: MAY 8, 1987

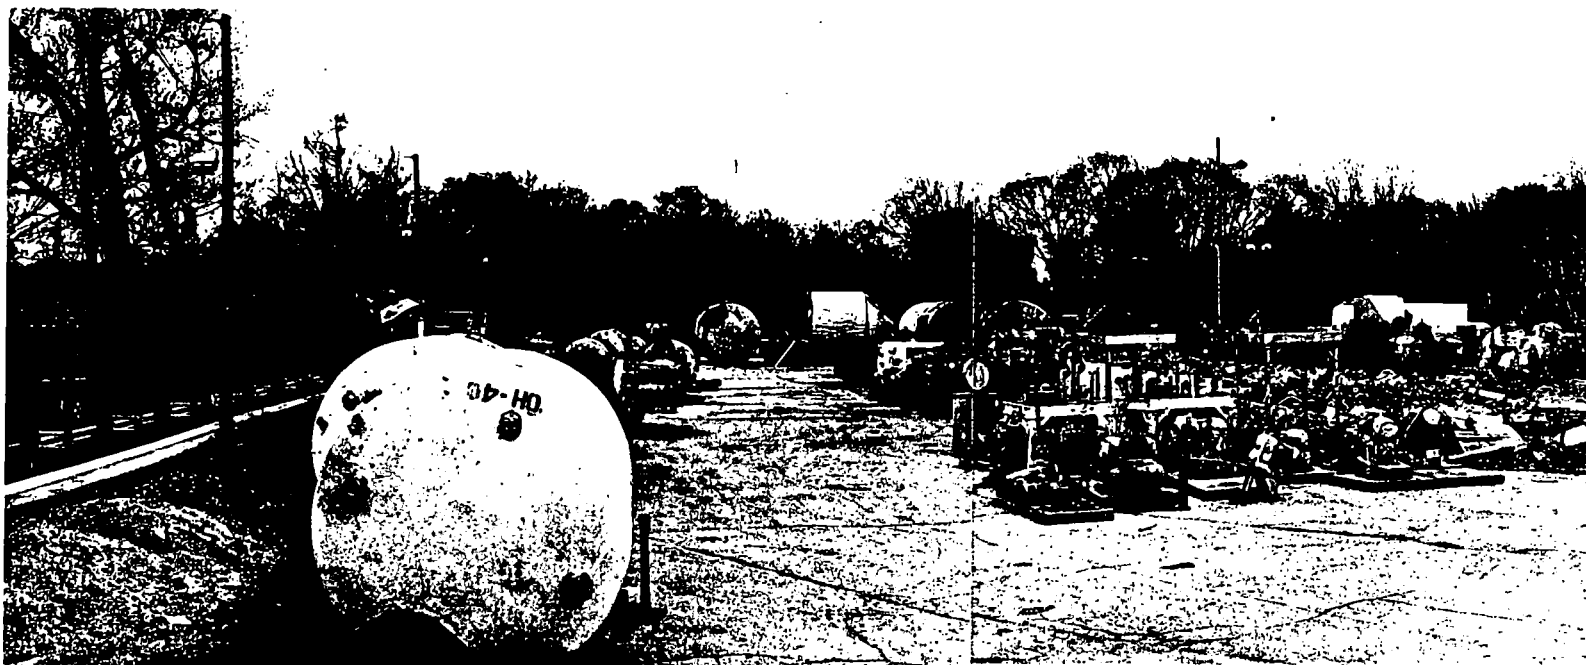
PHOTO 4

Major process buildings and facilities that have been demolished and no longer exist onsite include building 10, steam plant; building 11, manufacturing; building 14, office; building 10/23, pilot plant; building 17/19, manufacturing; building 24, zinc recovery system; building 27, cooling tower; and the wastewater treatment plant. The demolition and removal of building 21/22 (manufacturing) had not yet been completed (Photo 2). No removal activities were being performed on the Warwick side of the facility, which was primarily being used for the temporary storage of equipment from the former production buildings (Photo 4).

SUBJECT: FORMER OUTSIDE DRUM STORAGE AREA PRESENTLY OCCUPIED BY EQUIPMENT FROM  
DISMANTLED PLANT LOOKING EAST.  
LOCATION: CIBA-GEIGY, WARWICK, RHODE ISLAND  
DATE: MAY 3, 1987

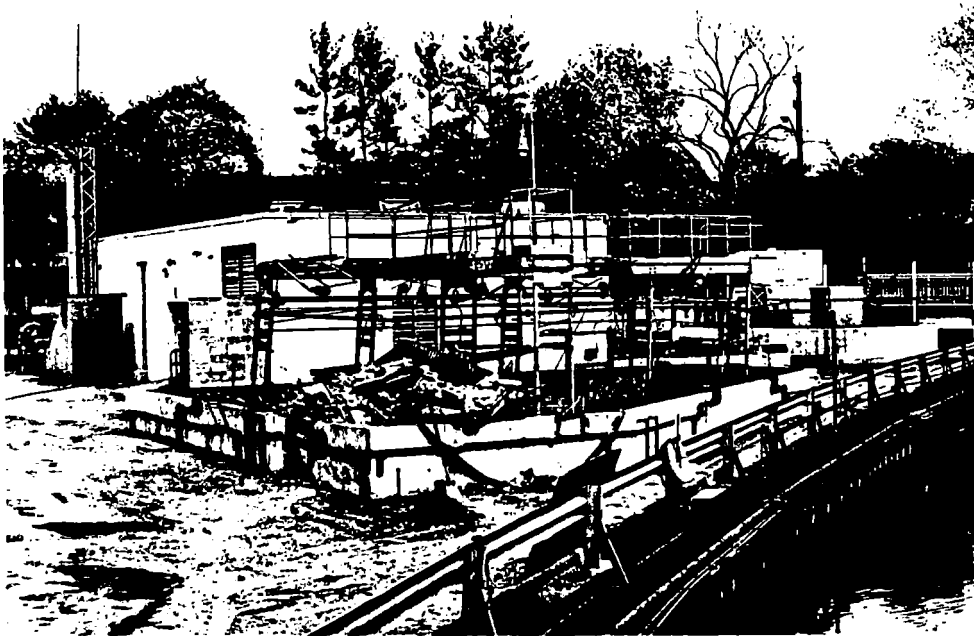
PHOTO 5

All storage tanks from the building 21 tank farm (Photo 5) and over-the-river tank farm (Photo 6) had been removed. Some debris had been placed within the containment structures of these tank farms. Standing surface water within the tank farms had accumulated as a result of drainage being sealed off by Ciba-Geigy. The main tank farm which previously contained SWMU 2 and SWMU 3 still housed a few other tanks (Photo 7). The means of drainage within the main tank farm had also been sealed off, and standing surface water had accumulated.

SUBJECT: BUILDING 21 TANK FARM LOCATION LOOKING NORTHEAST.  
TANKS HAVE BEEN REMOVED AND CONTAINMENT AREA FILLED WITH SOME DEBRIS.  
LOCATION: CIBA-GEIGY, CRANSTON, RHODE ISLAND  
DATE: MAY 8, 1987

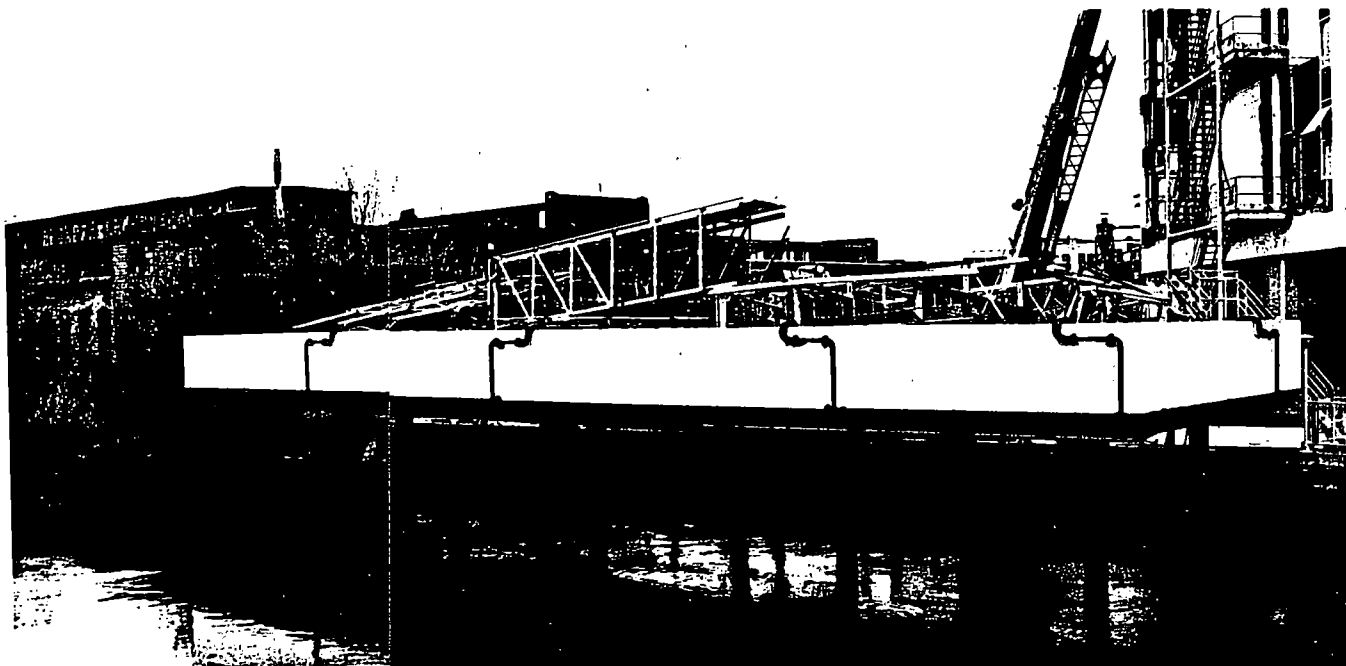
PHOTO 6

SUBJECT: OVER-THE-RIVER TANK FARM LOOKING WEST. TANKS HAVE BEEN REMOVED  
AND CONTAINMENT AREA FILLED WITH SOME DEBRIS.  
LOCATION: CIBA-GEIGY, CRANSTON, RHODE ISLAND  
DATE: MAY 8, 1987

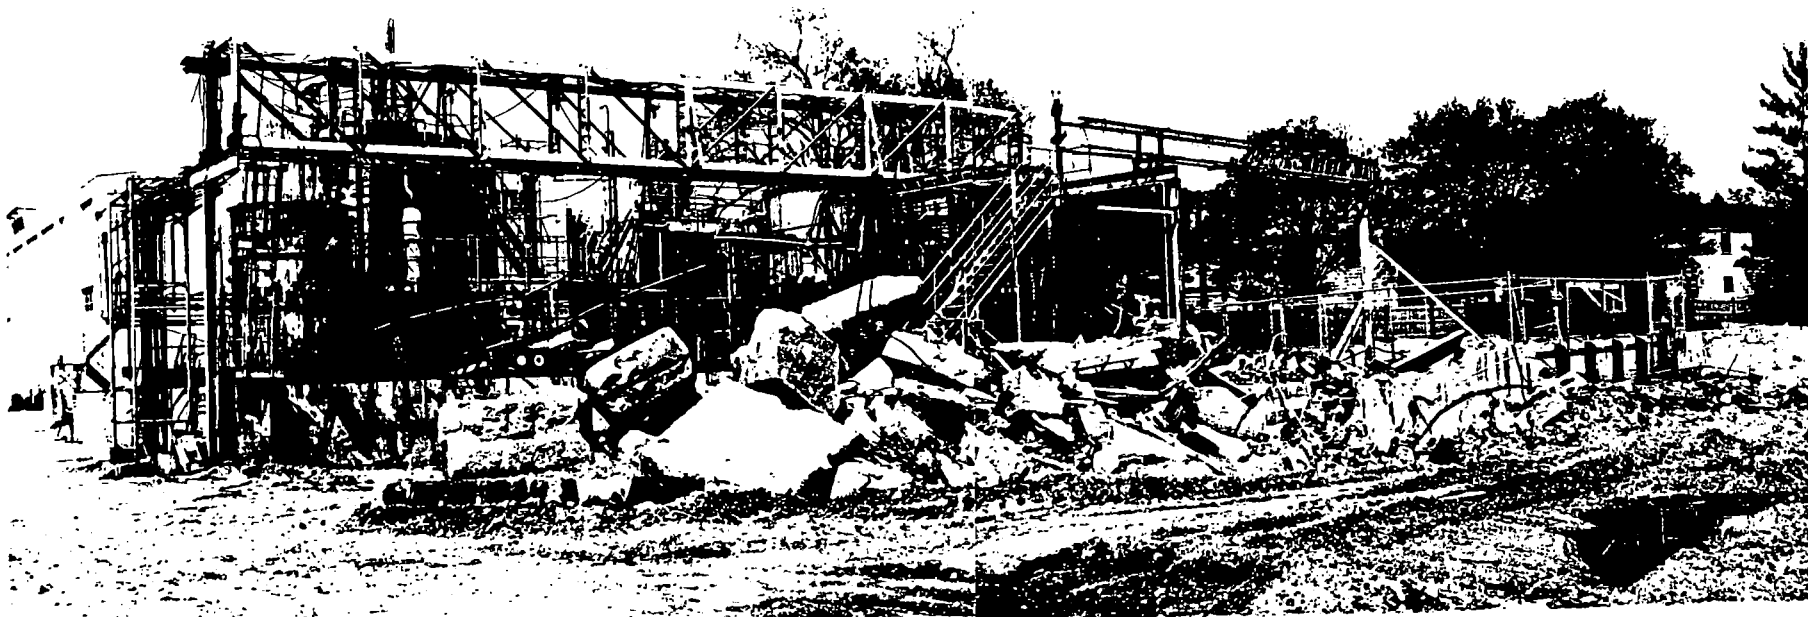
PHOTO 7

SUBJECT: MAIN TANK FARM AND DEMOLITION DEBRIS FROM BUILDING 10,  
STREAM PLANT LOOKING NORTHEAST.  
LOCATION: CIBA-GEIGY, CRANSTON, RHODE ISLAND  
DATE: MAY 8, 1987

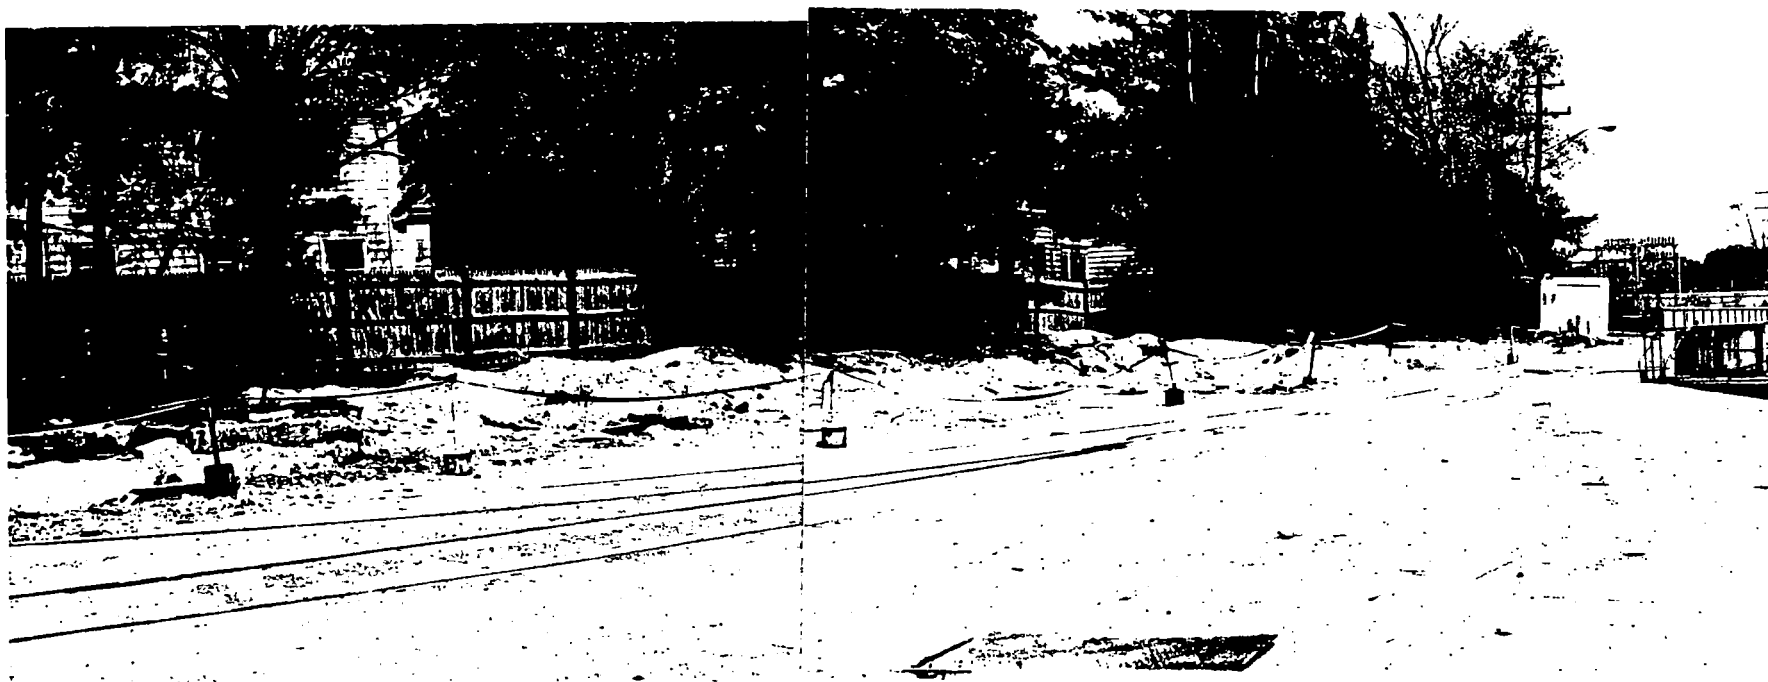
PHOTO 8

The former location of Ciba-Geigy's underground bulk solvent and raw material storage tanks was found northwest of the production area adjacent to residential property in Cranston (Photo 8). Eight 10,000-gallon storage tanks previously used to store toluene, acetone, isopropyl alcohol, and other solvents had been removed from this area. Soils around the tanks had been excavated, and the entire area was backfilled with a sandy material. The location of one underground gasoline tank and two underground fuel oil tanks was also found during

SUBJECT: FORMER LOCATIONS OF EIGHT 10,000-GALLON UNDERGROUND STORAGE TANKS USED BY  
CIBA-GEIGY FOR RAW MATERIAL STORAGE, LOOKING EAST.  
LOCATION: CIBA-GEIGY, CRANSTON, RHODE ISLAND  
DATE: MAY 8, 1987

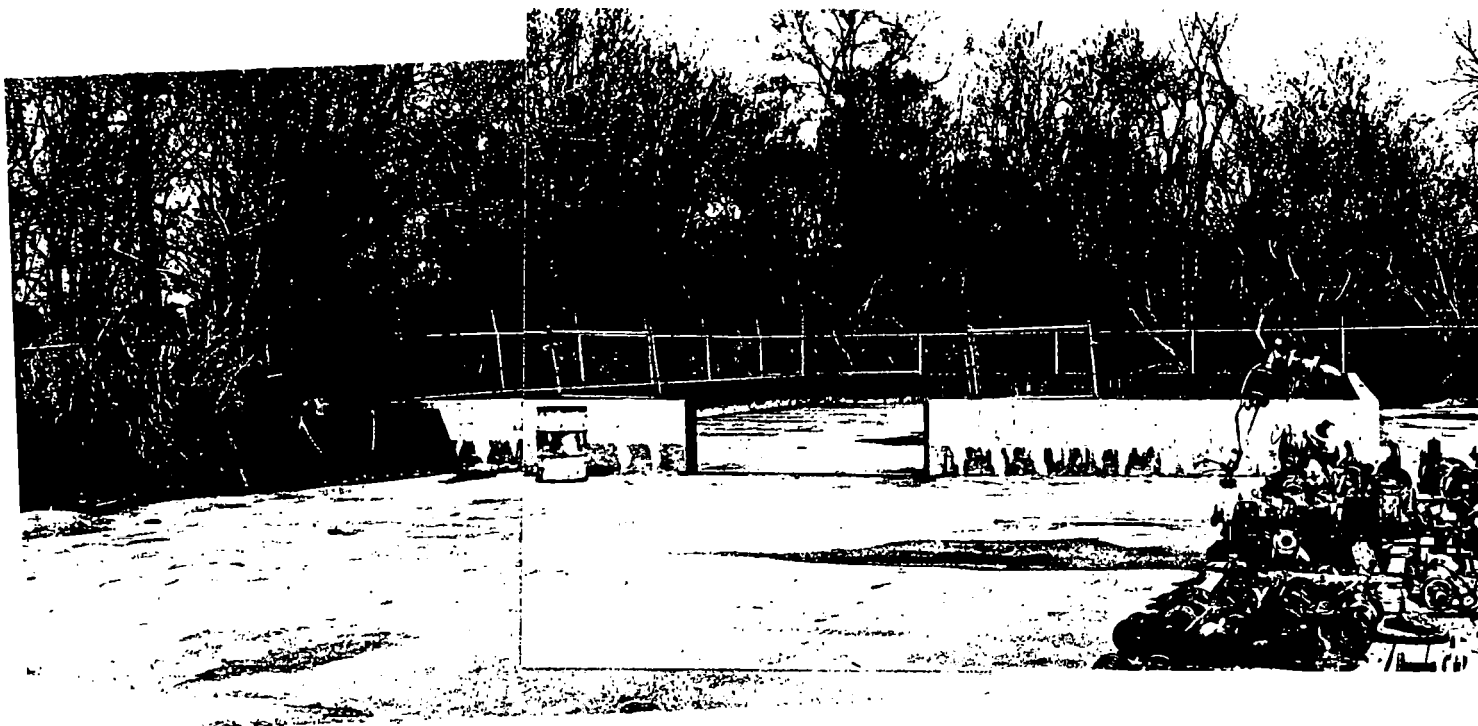
PHOTO 9

At the time of the VSI, all drums had been removed from the area. The SWMU had been cleaned, and no evidence of any releases was apparent. The potential of exposure to any wastes previously managed in this SWMU is negligible. Prior to the construction and use of SWMU 1, hazardous waste drums were stored in the production area near the trash compactor.

SUBJECT: CONTAINMENT AREA AND LOCATION OF SWMU 1,  
HAZARDOUS WASTE STORAGE AREA (DRUMS) LOOKING NORTHEAST.  
LOCATION: CIBA-GEIGY, WARWICK, RHODE ISLAND  
DATE: MAY 8, 1987

- SWMU 1 - Hazardous Waste Storage Areas (Drums)
- SWMU 4 - Trash Compactor
- SWMU 6 - Zinc Oxide Pile

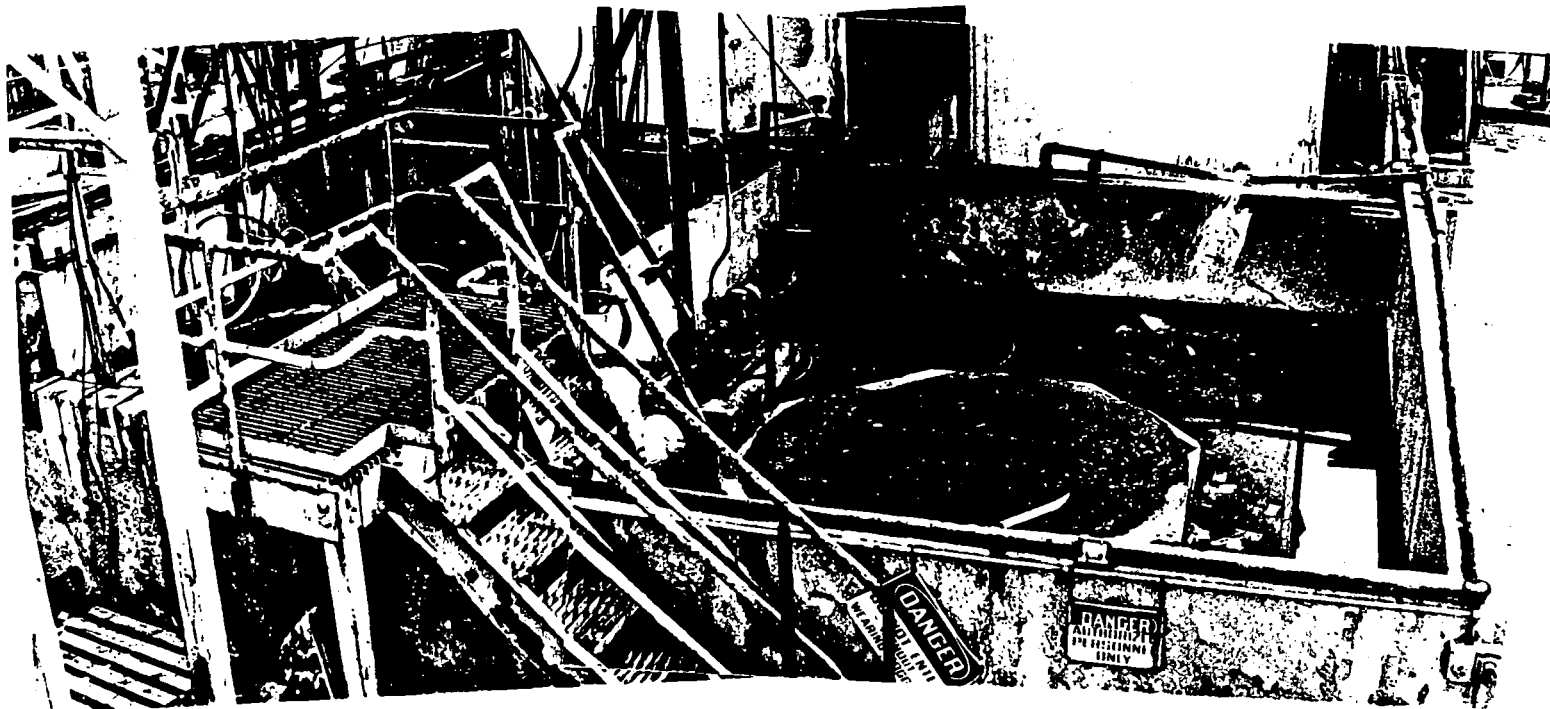
PHOTO 10

SWMU 2 is located in the main tank farm near the Mill Street entrance to the Ciba-Geigy facility. The tank was located in a concrete-diked enclosure (Photo 10). During the VSI, this area contained the tank's storage pad and standing surface water. Drainage from the enclosure had previously occurred by way of underground piping to the wastewater treatment plant. This drainage pathway was sealed off according to the hazardous waste storage permit, and subsequently water had to be pumped out of the enclosed area.

No evidence of releases was apparent in or around this SWMU. Subsurface infiltration is a likely pollutant migration pathway from this SWMU. A release to the ground water in the former building 11 area (SWMU 11) near the main tank farm has been identified (Ciba-Geigy, 1985a). Air monitoring of subsurface openings in the former production area downgradient of the main tank farm has revealed the possible presence of organic vapors above background levels. The potential of exposure to releases from the storage tank in the subsurface could not be determined.

SUBJECT: CONTAINMENT AREA AND STORAGE PADS FOR SWMU 2, 6,000-GALLON HAZARDOUS WASTE  
STORAGE TANKS (right), 7,500-GALLON 90-DAY ACCUMULATES TANK (left).  
LOCATION: CIBA-GEIGY, WARWICK, RHODE ISLAND  
DATE: MAY 8, 1987

- SWMU 2 - 6,000-Gallon Hazardous Waste Storage Tank
- SWMU 3 - 7,500-Gallon 90-Day Accumulation Tank
- SWMU 5 - Former Silt Pile

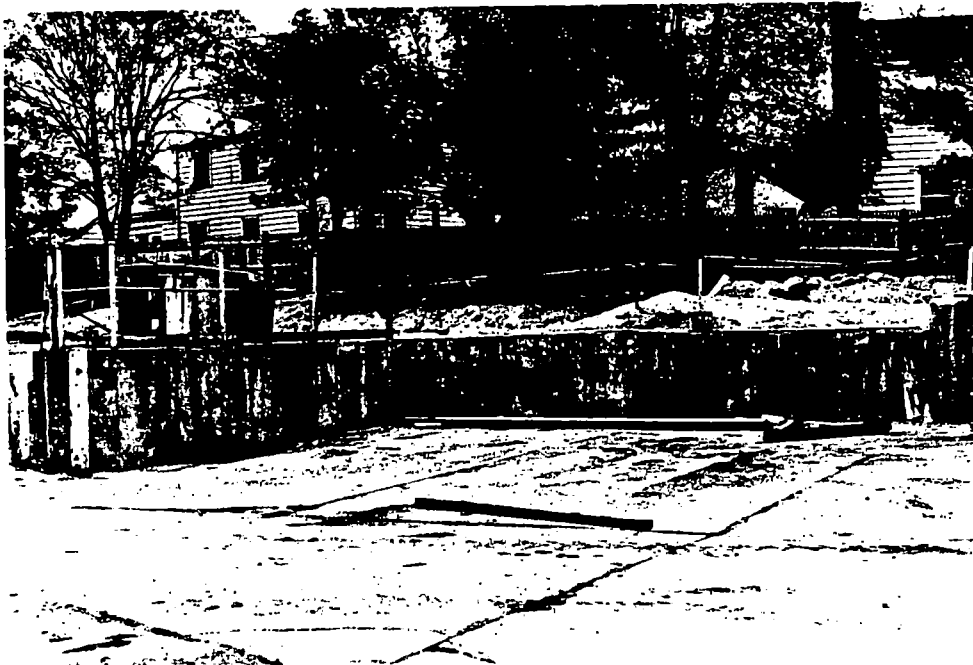
PHOTO 11

The trash compactor was formerly located north of building 27 adjacent to the railroad tracks, and it sat on a concrete base. The entire area surrounding this SWMU was covered with either concrete or asphalt. Drainage from the trash compactor flowed to a nearby surface drain leading to the facility's waste treatment plant. Few remnants of the SWMU exist at its former location (Photo 11). No process wastes were reportedly placed into the compactor (Ciba-Geigy, 1985a), and no releases have been documented from this unit. The potential of exposure to any possible releases from the SWMU is negligible.

SUBJECT: FORMER LOCATION OF SWMU 4, TRASH COMPACTOR, LOOKING NORTHWEST.  
LOCATION: CIBA-GEIGY, CRANSTON, RHODE ISLAND  
DATE: MAY 8, 1987

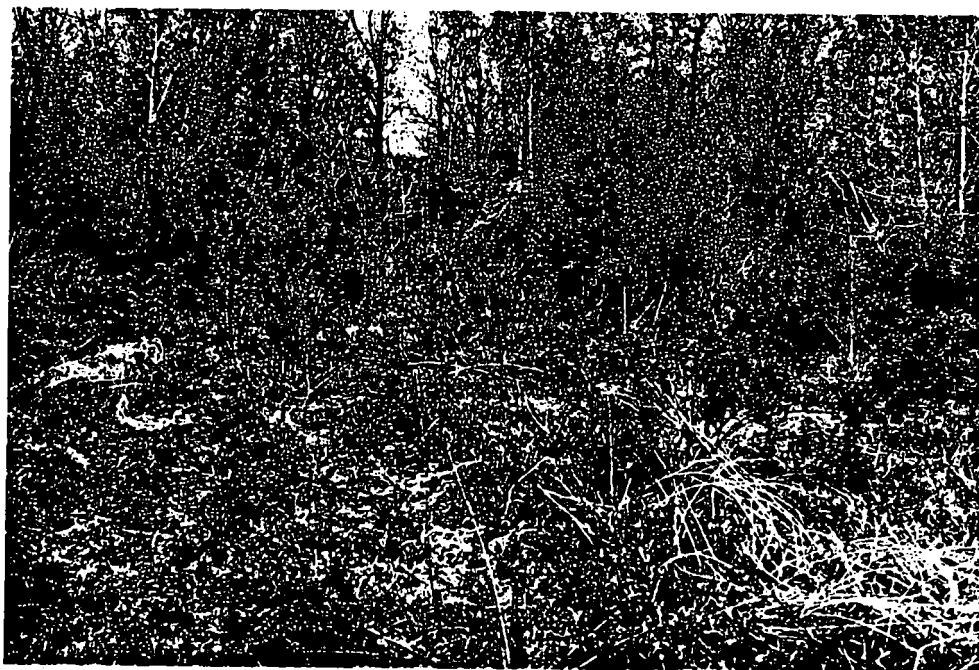
PHOTO 12

The location of the former silt pile on the Warwick side of the facility was examined during the VSI. Most of the area, situated in the northeast corner of the Warwick property near the river, was overgrown with vegetation (mostly grasses). Some bare areas within the SWMU location did exist (Photo 12). The total area previously covered by the silt pile could not be determined. Two ground water level measurement pipes were found near the former silt pile.

The silt pile was placed onsite after being dredged from the Pawtuxet River upstream of the Ciba-Geigy facility. No information exists regarding any waste characteristics of the pile. During the VSI, surface soils within the SWMU area were distributed and monitored with the TIP photoionization unit. Readings were 1 - 6 ppm above background levels, which may indicate residual contamination.

subsurface infiltration. Although the pile was removed and soils in the area excavated, residual contamination may exist. The potential of exposure to contaminants in the surface soils exists, since access to the area is unrestricted. The potential of exposure to contaminants in the subsurface could not be determined.

SUBJECT: LOCATION OF SWMU 5, FORMER SILT PILE, ON WARWICK PROPERTY EAST OF THE PLANT. .  
THE PILE WHICH WAS DREDGED FROM THE PAWTUXET RIVER UPSTREAM OF THE FACILITY  
WAS REMOVED IN DECEMBER 1976.  
LOCATION: CIBA-GEIGY, WARWICK, RHODE ISLAND  
DATE: MAY 8, 1987

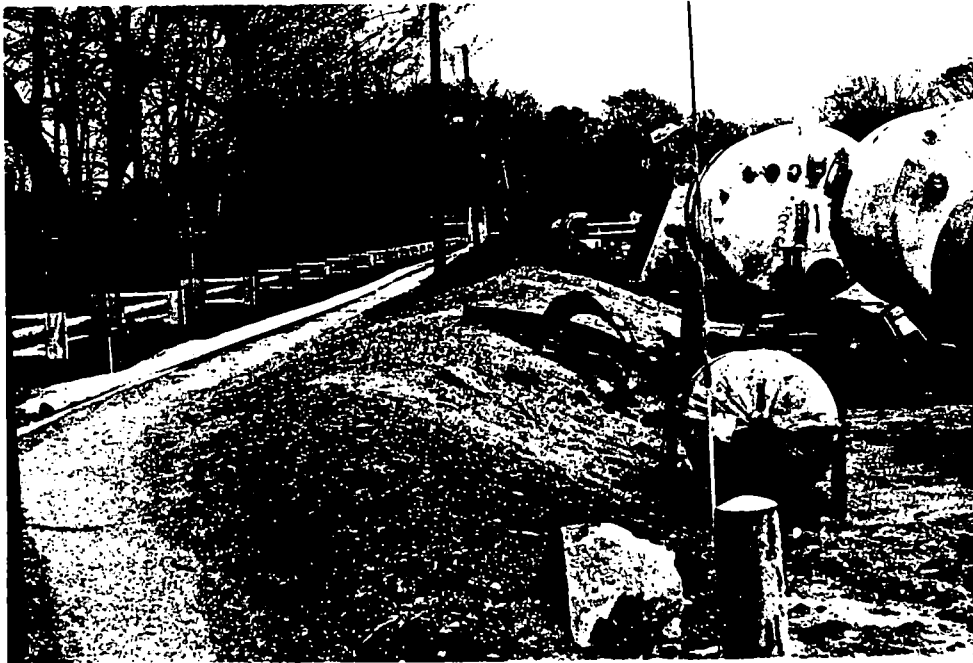
PHOTO 13

A major part of the zinc oxide pile still exists on site. The pile is located on the Warwick side of the facility, north of building 32 and adjacent to the guardrail that supported the main wastewater pipeline along the Pawtuxet River (Photo 13). The pile is approximately 7 feet wide by 50 feet long, and 2 feet high (26 cubic yards), and it consists of soil and lumps of zinc oxide. Surface runoff from the area discharges to the river by way of outfall 003. The presence of zinc oxide is evident in the pile, but releases from this unit and the potential of exposure are not major concerns because of the innocuous nature of the material.

SUBJECT: LOCATION OF SWMU 6, ZINC OXIDE PILE LOCKING EAST.  
LOCATION: CIBA-GEIGY, WARWICK, RHODE ISLAND  
DATE: MAY 8, 1987

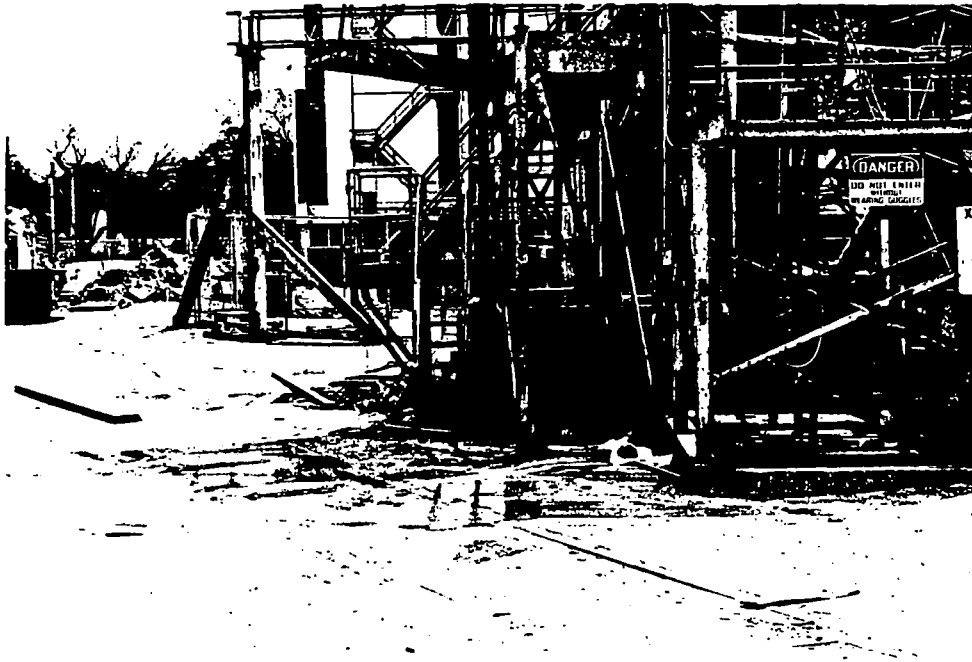
PHOTO 14

The chlorosulfonic acid spill occurred within the area bordered by the railroad spur adjacent to the main tank farm (Photo 14). Most if not all of the area covered by the spill was reportedly neutralized and excavated for the new tank farm foundations (Ciba-Geigy, 1985a). Evidence of release has not been documented, since the area is presently covered by the tank farm. Similarly, contaminant migration and exposure potentials have not been determined.

SUBJECT: LOCATION OF SWMU 7, CHLOROSULFONIC ACID SPILL, IN AREA BETWEEN RAILROAD TRACKS AND TANK FARM LOOKING SOUTH. PART OF THE TANK FARM COVE S THE FORMER SPILL AREA.

- SWMU 7 - Chlorosulfonic Acid Spill Area
- SWMU 8 - Potassium Ferrocyanide Spill Area
- SWMU 9 - Wastewater Pipeline Break (January 12, 1982)
- SWMU 10 - Wastewater Pipeline Break (September 7, 1983)
- SWMU 11 - Building 11 Area (Toluene)

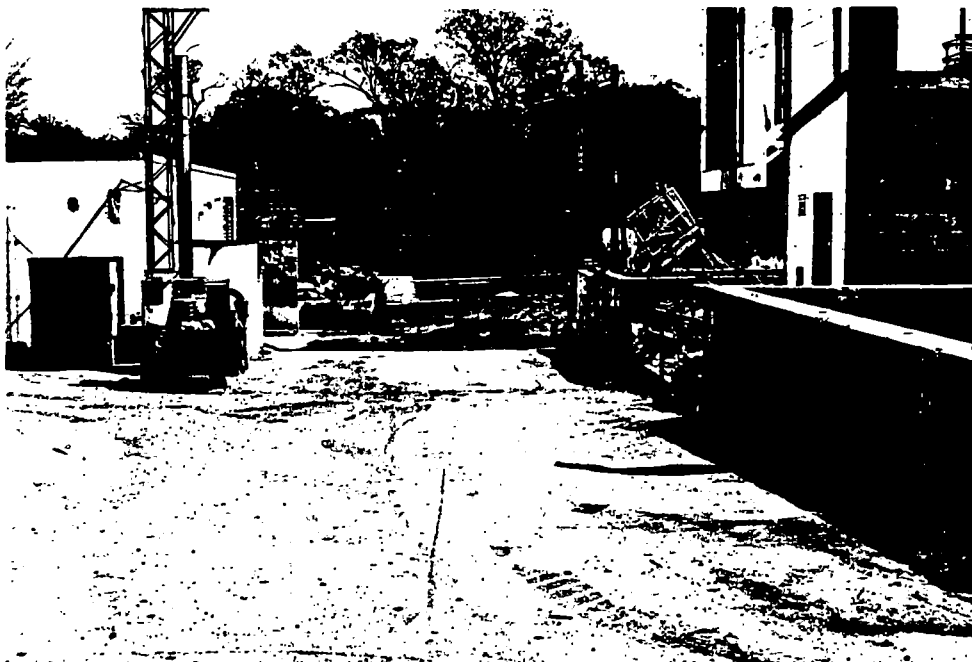
PHOTO 15

During the VSI, a former area of blue-stained soil was located. The area resulted from a spill of an unknown quantity of potassium ferrocyanide (Prussian blue), and it was excavated by Ciba-Geigy around 1961 (Ciba-Geigy, 1985a). Facility representatives indicated that the Prussian blue was only found in the one area located between building 27

and former building 24 (Photo 15). Evidence of release has not been documented, since this area has been paved. Similarly, contaminant migration and exposure potential have not been documented.

SUBJECT: LOCATION OF SWMU 8, POTASSIUM FERROCYANIDE SPILL AREA LOOKING SOUTH. SPILL  
WAS DETECTED DURING EXCAVATION PRIOR TO PAVING THE AREA.  
LOCATION: CIBA-GEIGY, CRANSTON, RHODE ISLAND  
DATE: MAY 3, 1987

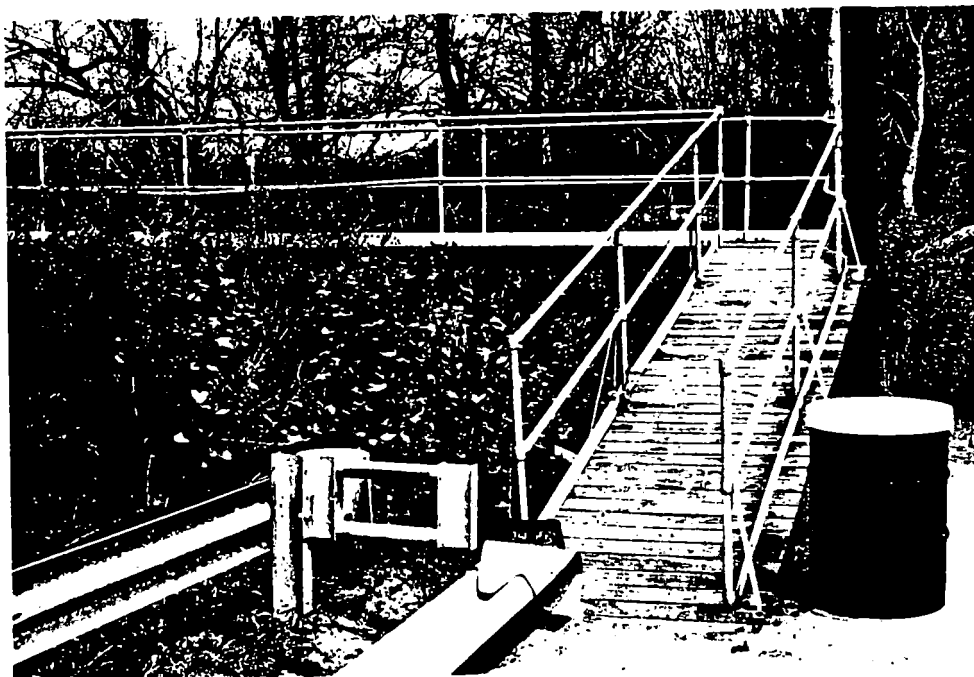
PHOTO 16

SWMU 9 was found on the southern side of the facility at the point where the pipeline turned to cross the bridge to the wastewater treatment plant (Photo 16). The entire pipeline has been removed. The guardrail that supported the pipeline remains in place, revealing the former layout of the wastewater line. The area surrounding the point of the pipeline break revealed no evidence of past release. Apparently, all of the wastewater that was discharged during the break flowed to the river. No information regarding any residual contamination in the area exists. Potential contaminant migration is via surface runoff to the river. Potential exposure pathways include contact with contaminated soils or the river.

SUBJECT: LOCATION OF SWMU 9, WASTEWATER PIPELINE BREAK (JANUARY 12, 1982)  
LOOKING NORTHEAST. PIPELINE HAS BEEN REMOVED BUT CARRIED WASTEWATER  
ACROSS BRIDGE TO TREATMENT PLANT.  
LOCATION: CIBA-GEIGY, WARWICK, RHODE ISLAND  
DATE: MAY 8, 1987

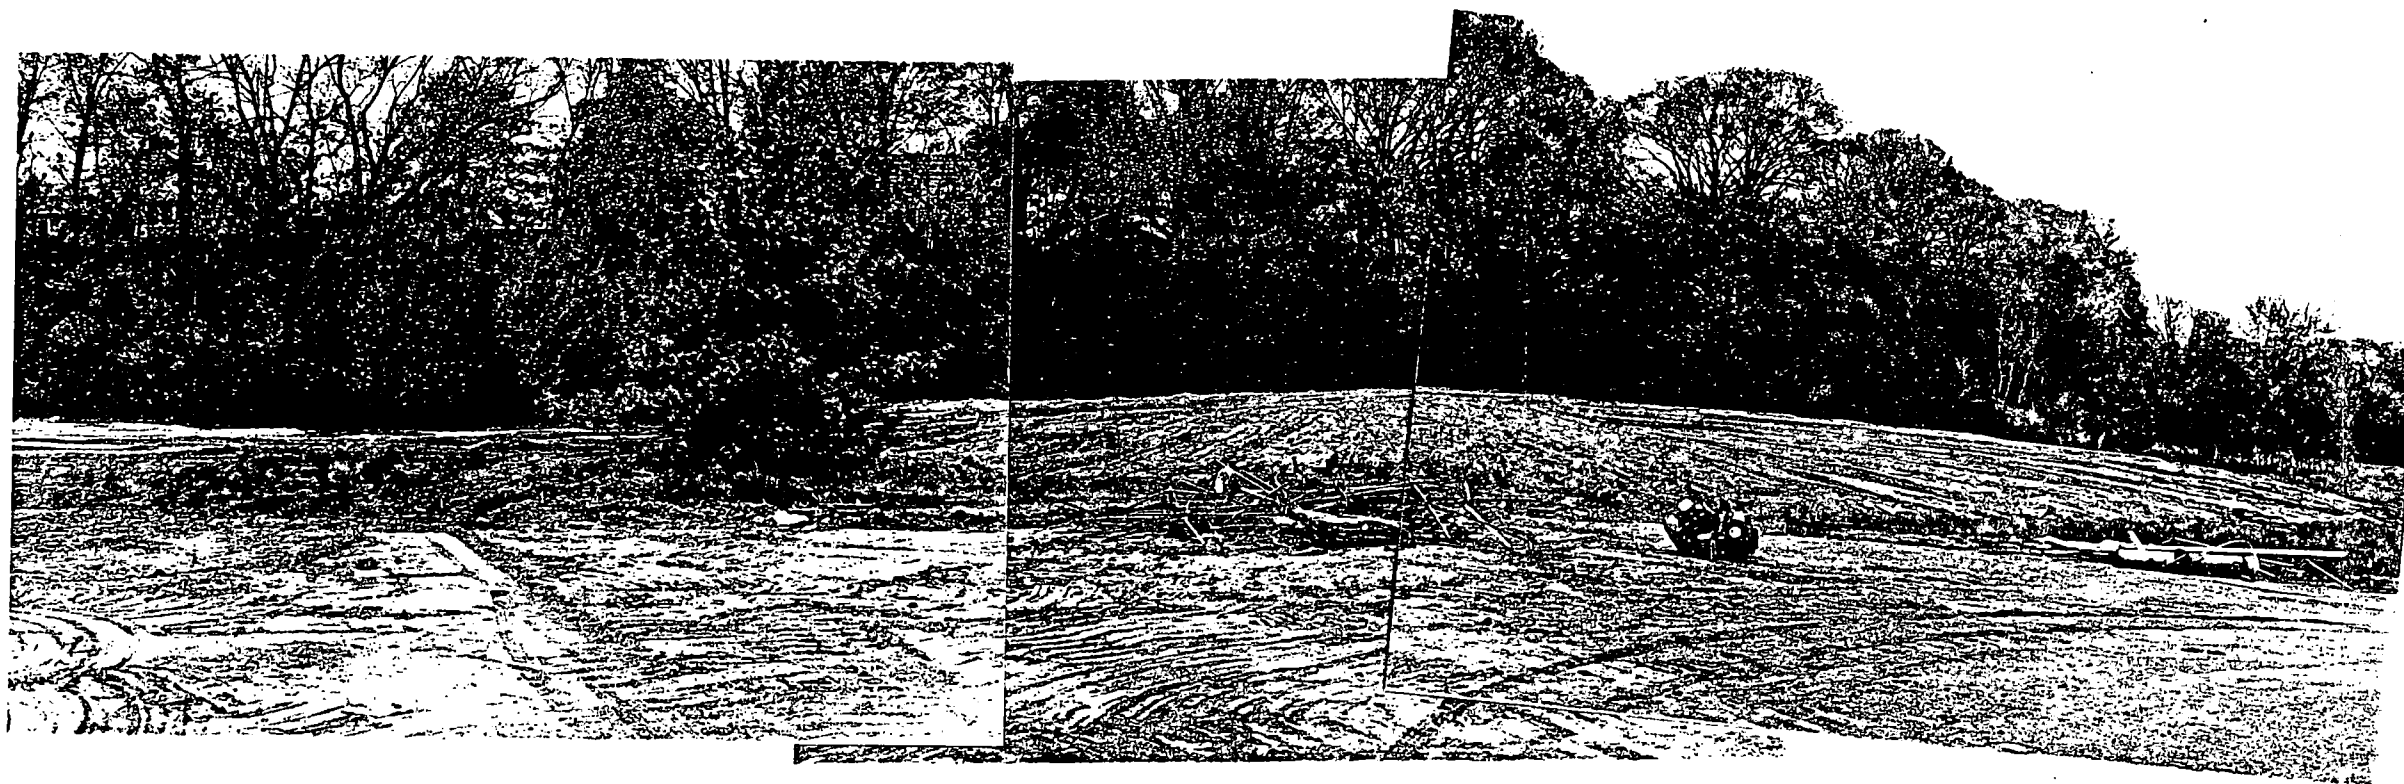
PHOTO 17

The general location of SWMU 10 was found at the former wastewater treatment plant site (Photos 17 and 18). The SWMU was identified as a result of a rupture in an underground line feeding two of the three equalization tanks (Ciba-Geigy, 1983). All structures and facilities at the treatment plant have been removed. Soils have been excavated, backfilled, and graded. The area surrounding the point of the pipeline rupture and the drainage pathway from the SWMU to the river revealed no evidence of past release.

SUBJECT: LOCATION OF SWMU 10, WASTEWATER PIPELINE BREAK (SEPTEMBER 7, 1983) AND THIRD  
EQUALIZATION TANK LOOKING NORTH. PIPELINE BREAK OCCURRED JUST WEST OF  
THE TANK.
